HISTORIC PRESERVATION CERTIFICATION
APPLICATION—PART 1

1. Name of property: 1700 West Lexington StreetAddress of property: 1700 West Lexington StreetCity Baltimore County _____ State Maryland Zip Code 21223Name of historic district in which property is located: Franklin Square Historic District

CONTINUATION SHEET FOR:
HISTORIC PRESERVATION CERTIFICATION APPLICATION - PART 1
1700 West Lexington Street
Baltimore, Maryland 21223

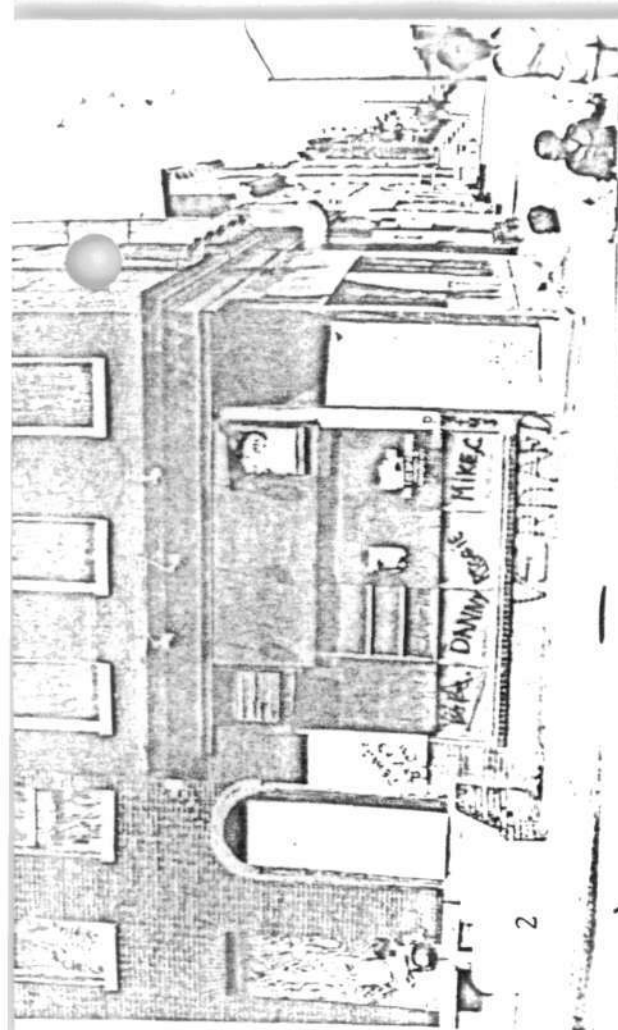
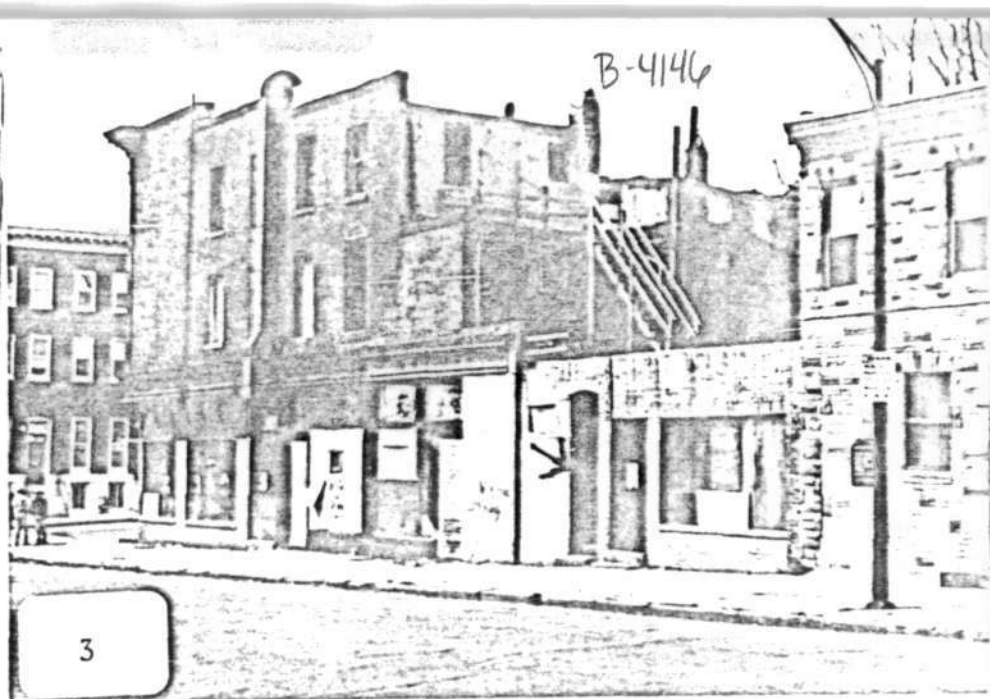
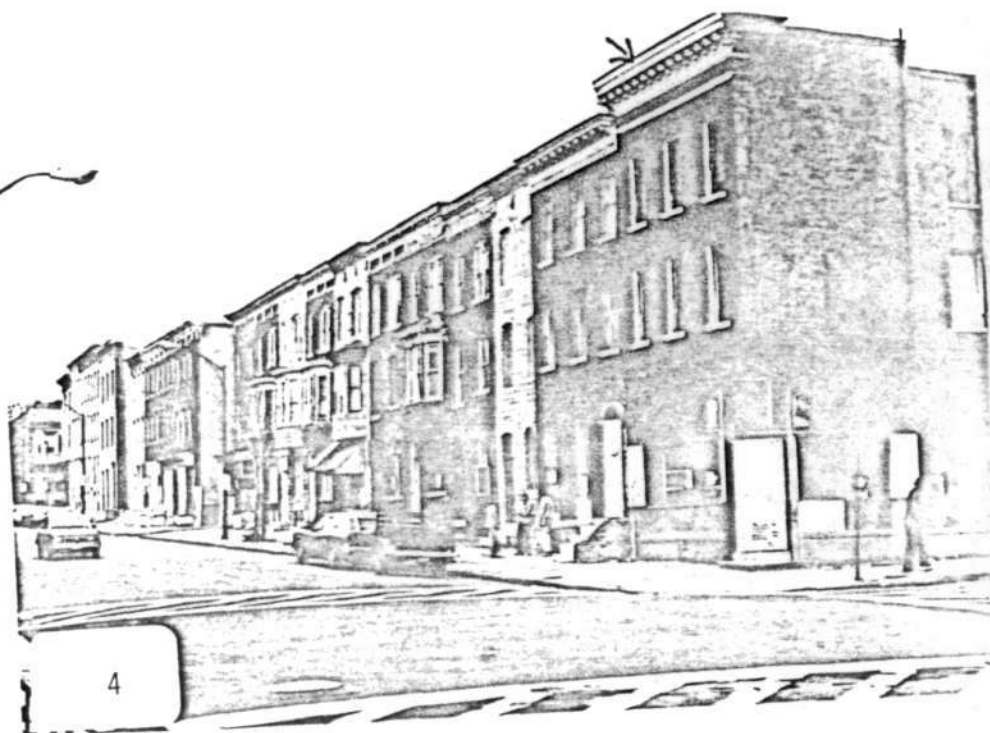
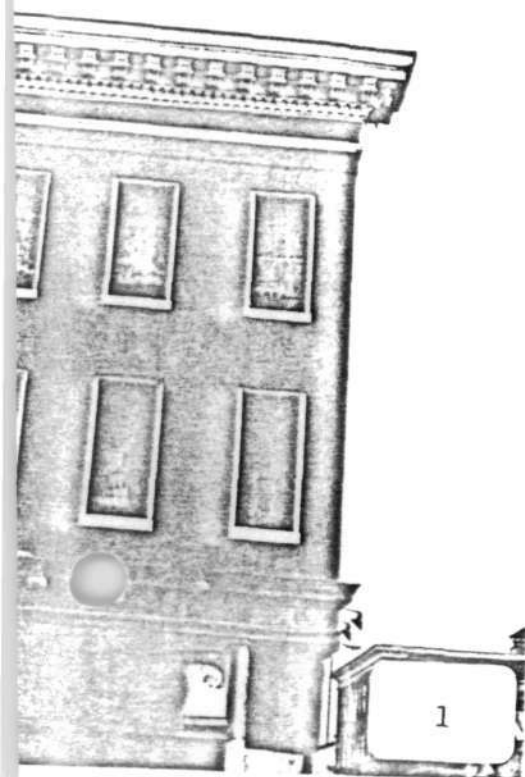
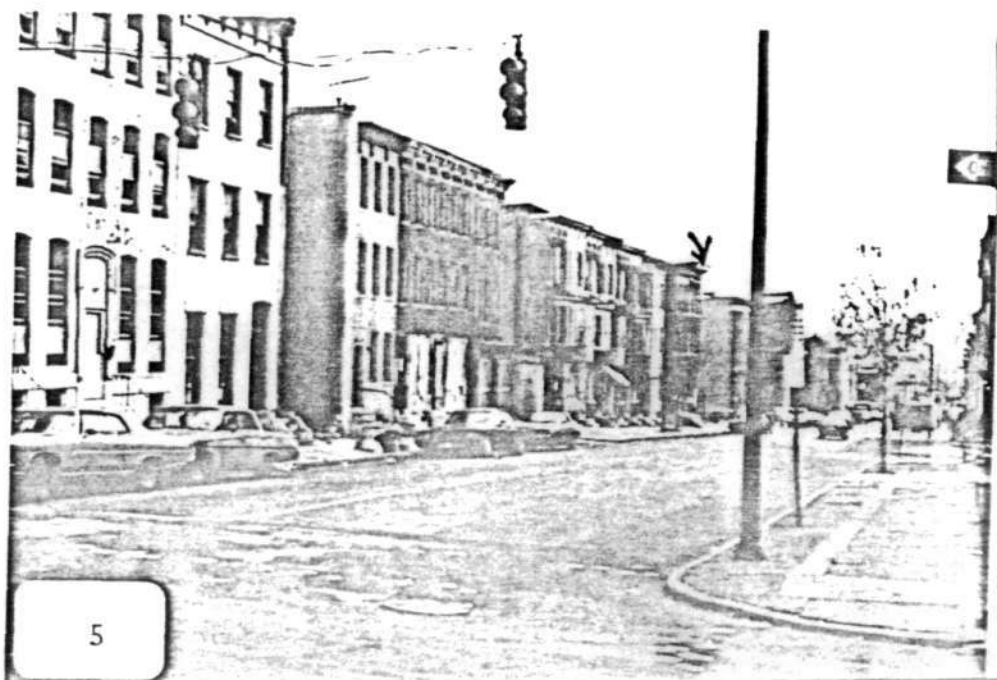
2. interior stairways to the second and third floors. There is an exterior rear wooden stairway that goes up the side and rear of the building to the second and third floors. A plain cornice runs along the front and side of the first floor over the storefront windows and a large decorative cornice tops the third floor front. There was no fireplace on the first floor and due to internal deterioration it was not possible to get to the upper two first floors. There was water and vandal damage to the first floor, however, some moldings, doors, casings and transoms exist.
(See photographs 1, 2, 3, 4, and 5.)

3. removed and replaced by outside wooden stairs that run up the side and back of the dwelling. There is a decorative ceiling in the front room of the storefront and some doors, moldings and casings remain that can be cleaned and used. The exterior facade is typical of other historical homes in the Franklin Square District, as are its high ceilings; it is unique in that in that it was converted to a storefront many years ago and is considerably larger than other homes on West Lexington Street.
(See photographs 1, 2, 3, 4, and 5.)

The storefront is typical of the flat front brick homes in Franklin Square and is topped with a large and decorative cornice. The brick exterior facade needs repointing, cleaning and repainting, however, the building has by majority, fairly plumb walls. The interior stairways have been (con't)
